USAAVLABS TECHNICAL REPORT 66-81

**20-HOUR FOLLOW-ON FLIGHT TEST PROGRAM,
XV-9A HOT CYCLE RESEARCH AIRCRAFT**

Summary Report on Task 1

**U. S. ARMY AVIATION MATERIEL LABORATORIES
FORT EUSTIS, VIRGINIA**

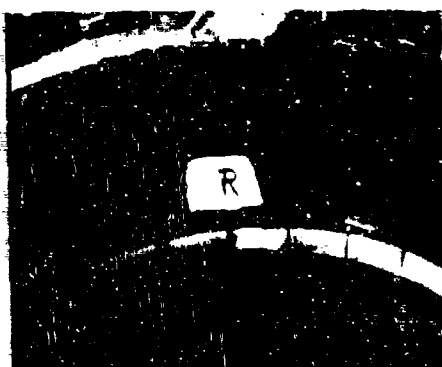
Red Blade Segment Seal
Typical Wear on Segmented Leaf Sliding Seals and Flame-Plated
Duct Walls

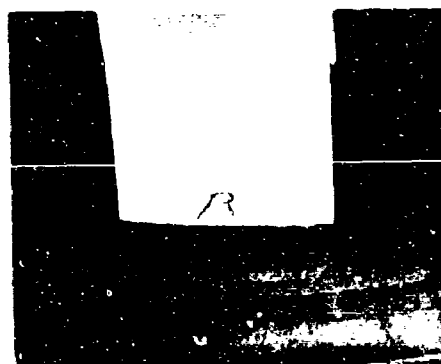
Figure 94. Articulating Duct, Hub to Blade.

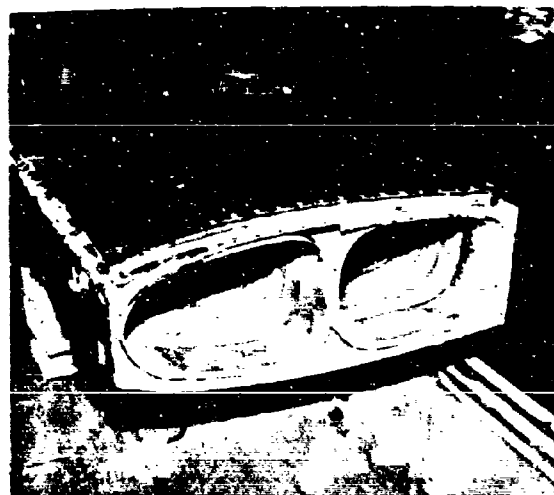
Flexure Ten Looking Outboard -
Small Seam Leak, Upper Left
Dark Area
